Stream House Community Association  
Orange, CA

Report #: 4702-10  
Beginning: January 1, 2023  
Expires: December 31, 2023

RESERVE STUDY  
Update "With-Site-Visit"

August 11, 2022

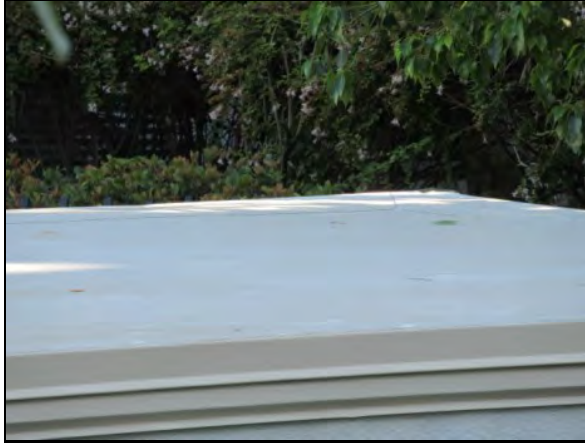
Comments: There was no access at the time of inspection. Expect to contact a qualified roofing contractor to inspect and advise on repair and maintenance needs. Per the association, all of the roofs are at the end of average life. They perform repair or replacement as funds allow, progressing through replacement doing what is possible each year.

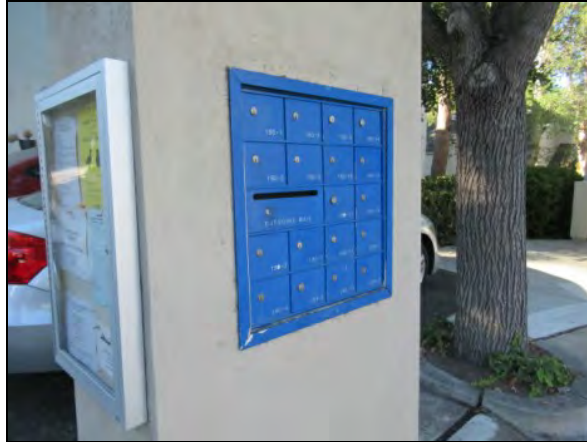
Comments: These vary in condition and age. The boxes have been repaired and replaced as needed, not all at one time. This component will allow for repair and replacement to be done to the boxes as necessary on an annual basis.

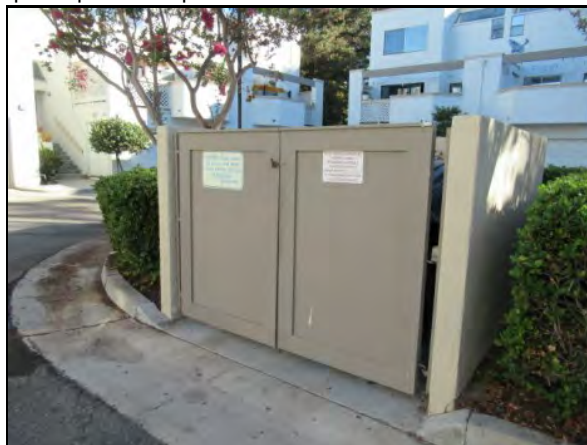
Comments: They are structurally sound, no mounting failure. No vandalism or mistreatment. They are being painted and repaired as they paint the community. Keep well painted to prevent wood deterioration.
