Stream House Community Association  
Orange, CA

Report #: 4702-10  
Beginning: January 1, 2023  
Expires: December 31, 2023

RESERVE STUDY  
Update "With-Site-Visit"

August 11, 2022

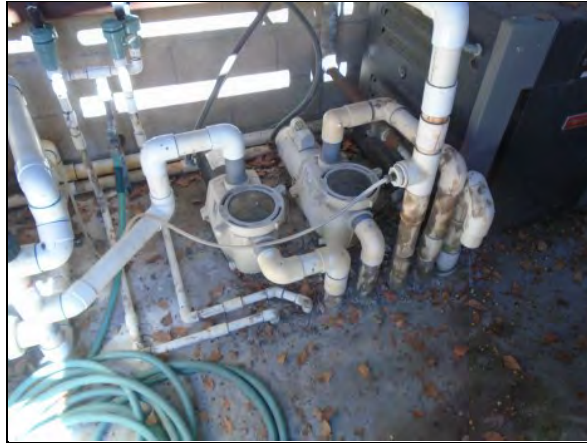
**Comp #: 1210 Pool/Spa Pumps - Replace**

Comments: No access upon inspection. Follow all repair and replacement recommendations of the pool maintenance vendor. Expect to repair or replace motors as needed using Operating funds. This component is to replace the entire pump-motor assembly.

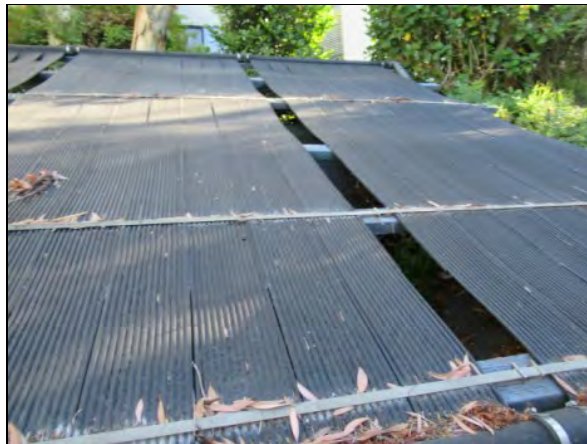
**Comp #: 1212 Solar Panels - Replace**

Comments: The panels look to be in good condition, no leaking evident. Follow maintenance recommendations of the service contractor.

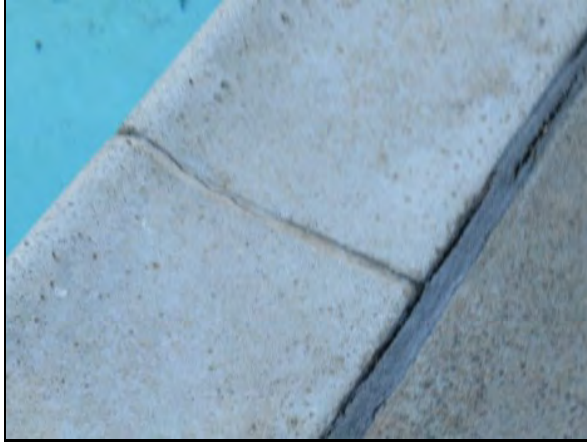
**Comp #: 1213 Pool Area Mastic - Replace**

Comments: The mastic is necessary to avoid water penetration under the deck which causes cracking and lifting. The mastic is dry, cracking and separating.
